# Manhole Inspection Summary

Manhole # S33S\_\_038MH

Insp Date: 1/31/08 1:13 PM

**Location** Address: **w.west st**

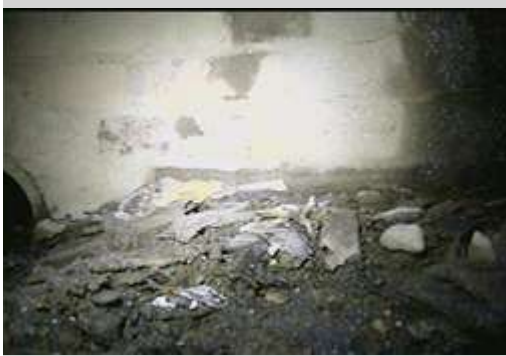
Defect 1

Condition: ☐ Sound ☐ Cracked ☐ Root Intrusion ☐ Deteriorated ☐ Leaks ☒ **Debris**

channel debris

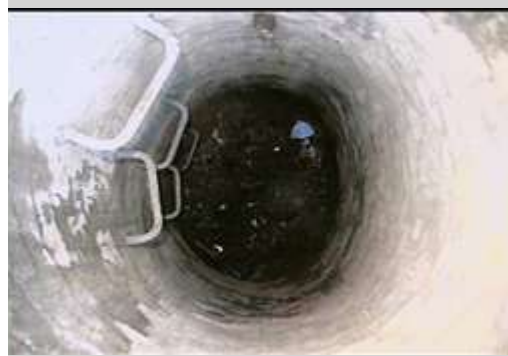
Defect 2

Count: **5** Missing: **0** ☒ **Corroded**

Corroded Steps

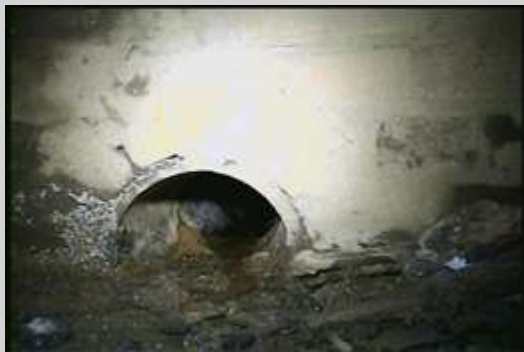
12 O'Clock Outflow

8 in. Circular Gravity Sewer  
Pipe Out @ 12 O'Clock

Deposits: ☐ None ☐ Mud ☒ Sludge ☒ Debris ☐ Grease

Silt Depth: **3** (in.) Deposits Extent: **Medium**

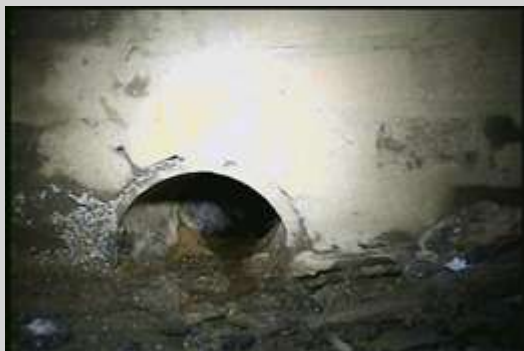
12 O'Clock Outflow

8 in. Circular Gravity Sewer  
Pipe Out @ 12 O'Clock

Deposits: ☒ None ☐ Mud ☐ Sludge ☐ Debris ☐ Grease
